Post-fill dive on the Northern Depression (Milwaukee Dock Restoration)

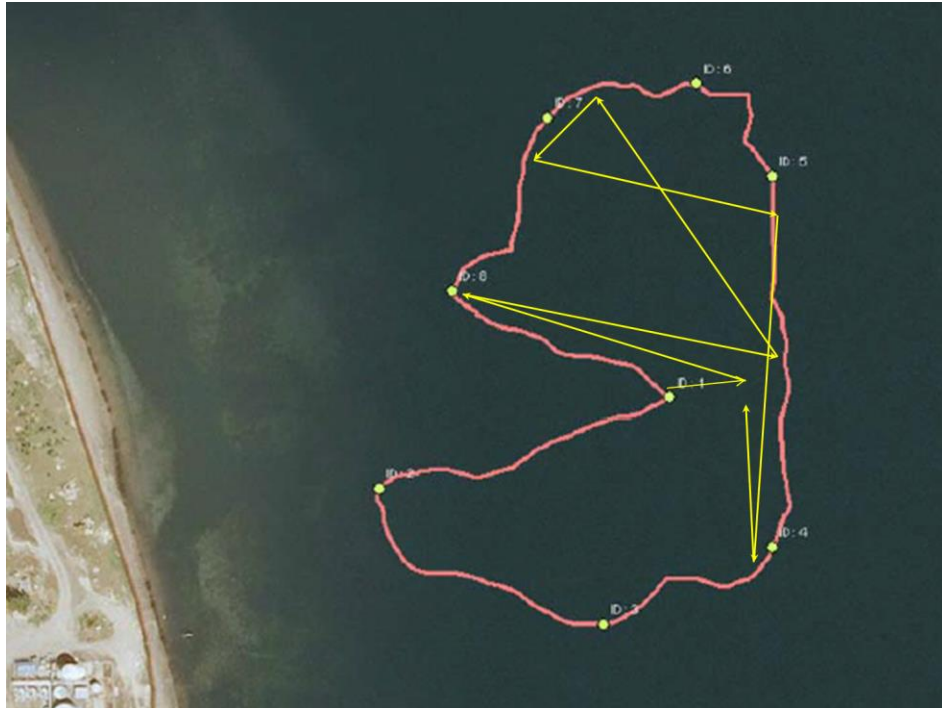
PNNL researchers conducted a dive on the northern depression on February 9 after the completion of fill operations. The divers were able to cover a good portion of the area on a number of crossing legs (see diagram), had good visibility throughout the dive, and were able to document the bottom with video. This is intended as a quick summary of the dive with some visuals to help others see the end results of the fill. The full video will be made available if possible. For reference in the diagram below, the dive started on the southern end of the northern depression near point D-1. The arrows then show the approximate path the divers took during the dive.

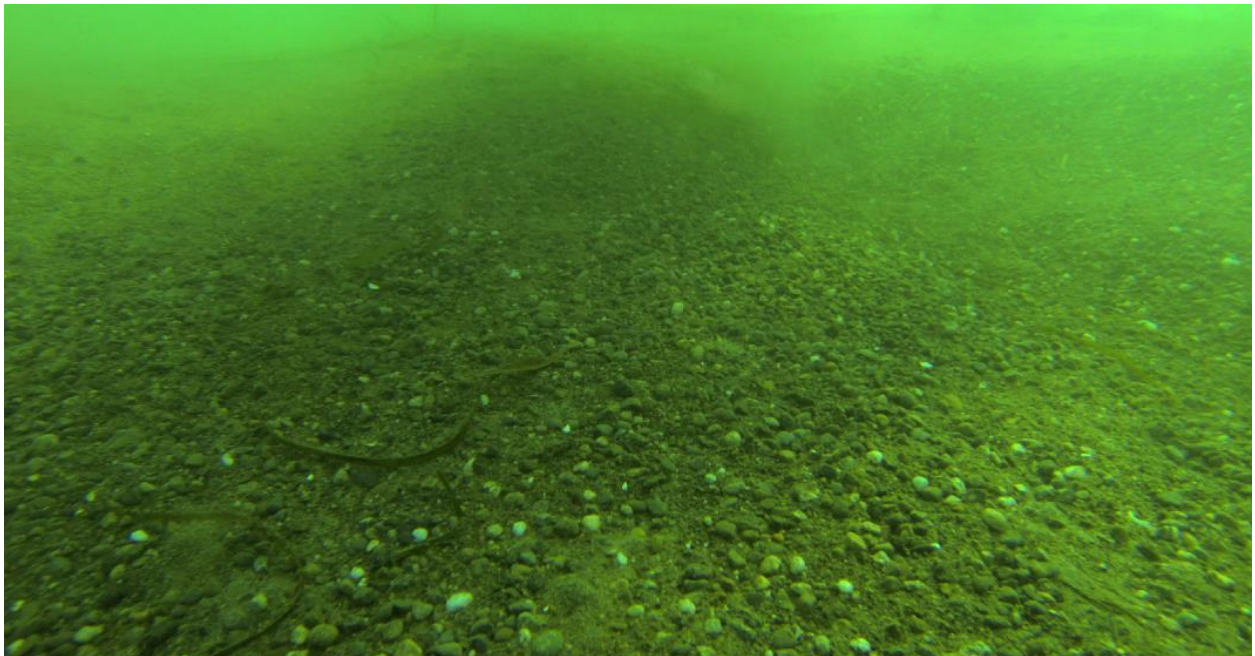
The coarse sediment toward the outer edge of the filled site (southern eastern end)

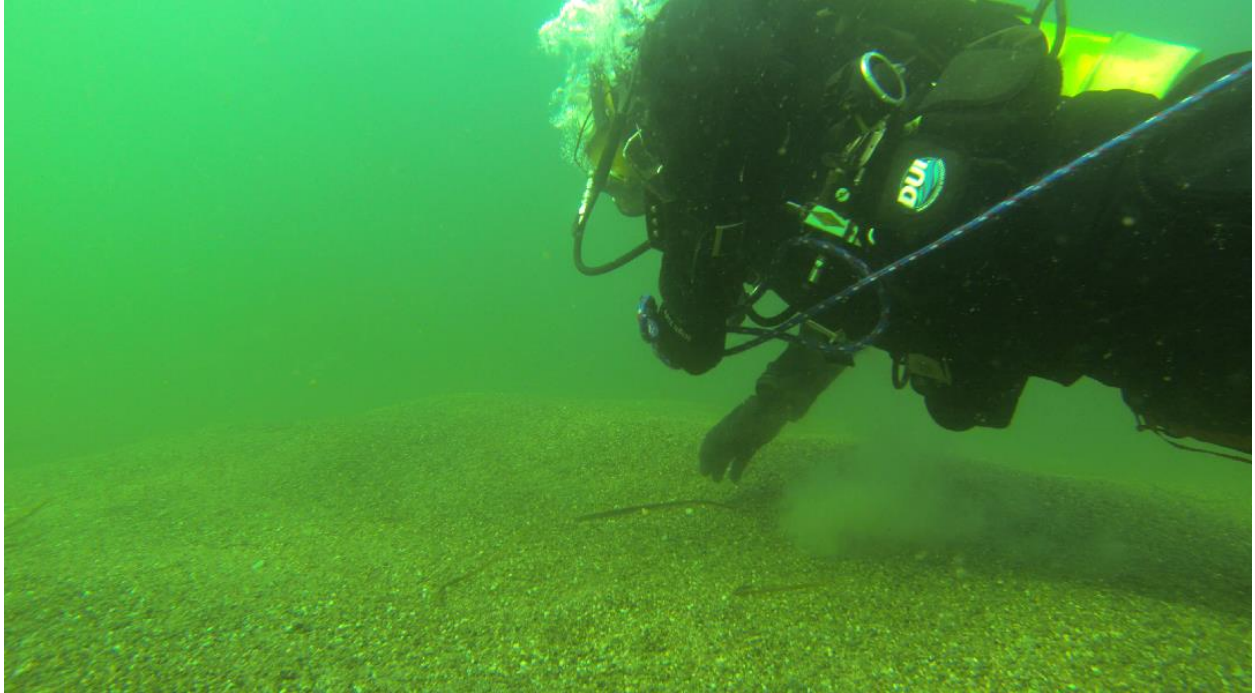
Some of the small mounded topography along the southern edge along the eelgrass between the two depressions. Notice the sediment grain size is finer than in the first photo.

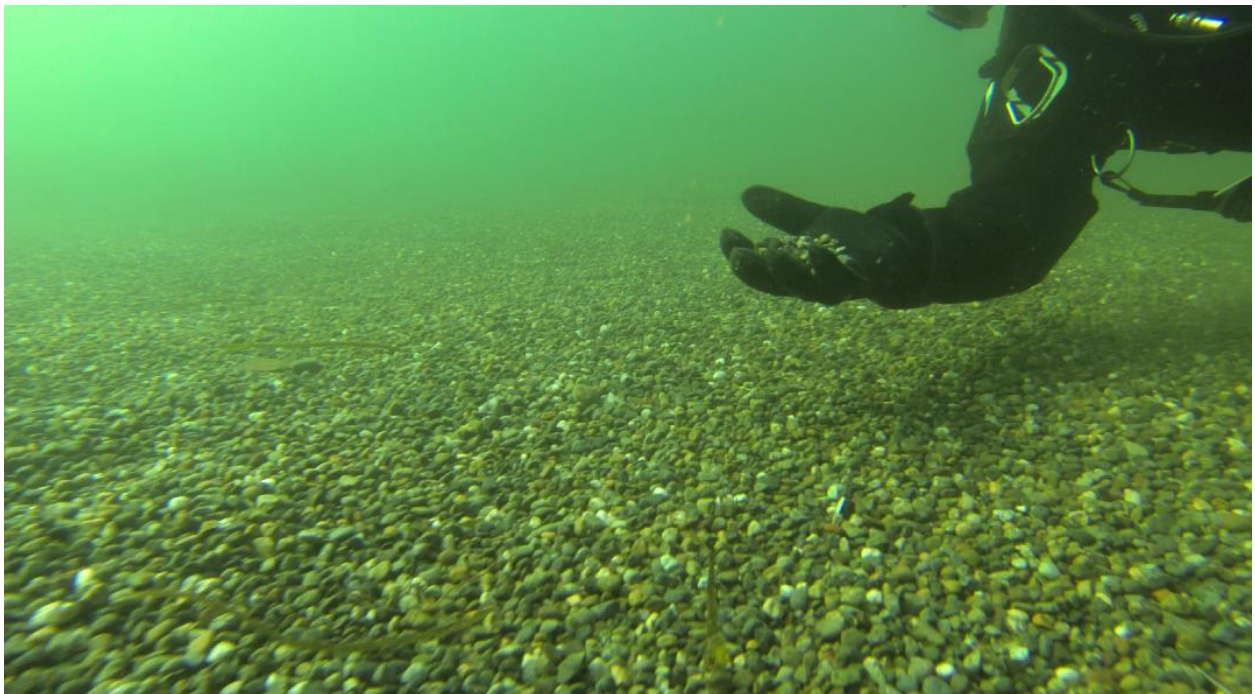
More very coarse material along the southern edge. This was shallower and not associated with the drop-off to the channel on the offshore side of the depression.

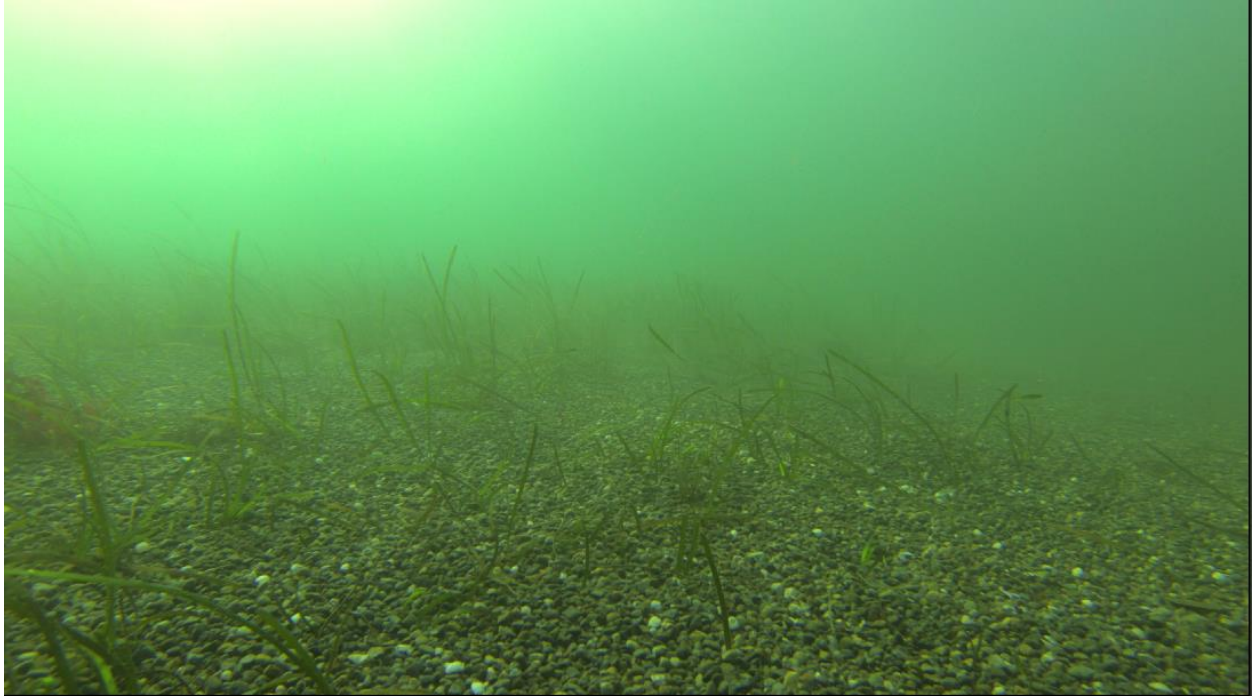
Coarse material on the southern edge of the depression that obviously spilled into the existing eelgrass. Luckily this was not the case for most of the perimeter, but suggests placement of the base layer may have been wider than finer capping material at this location.

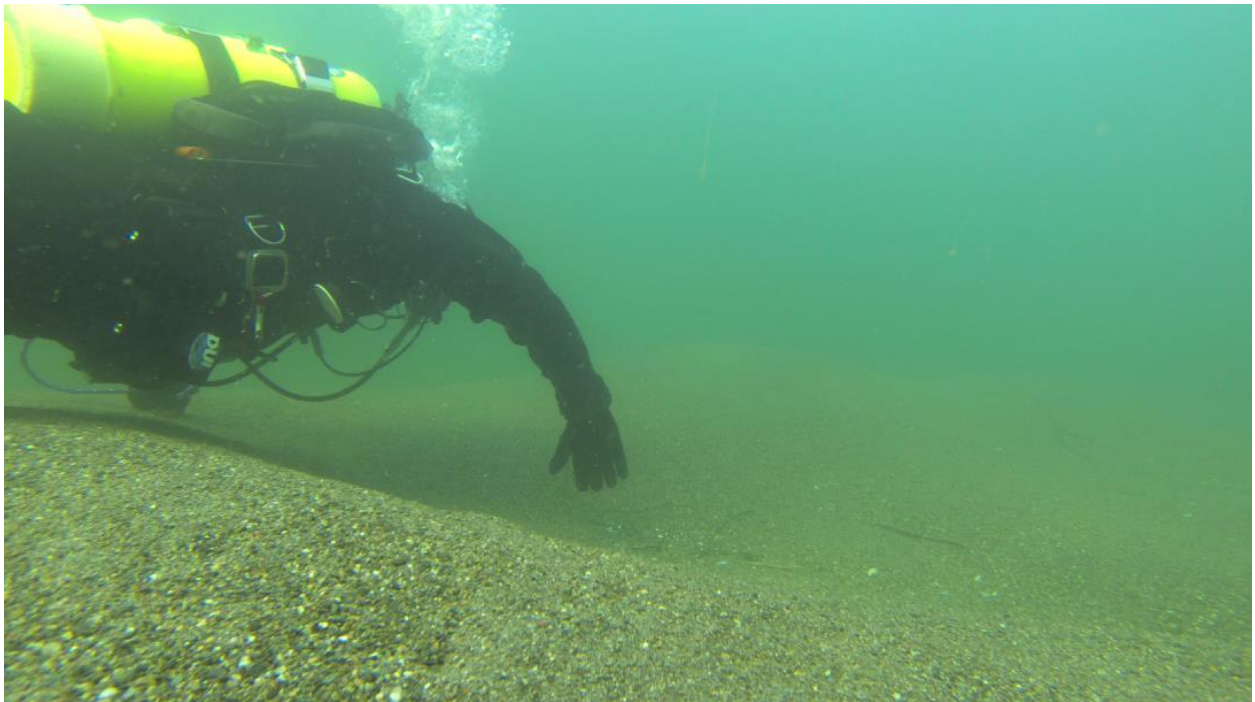
Some of the topography in the south eastern corner of the depression. Not sure if these depressions will catch drift algae.

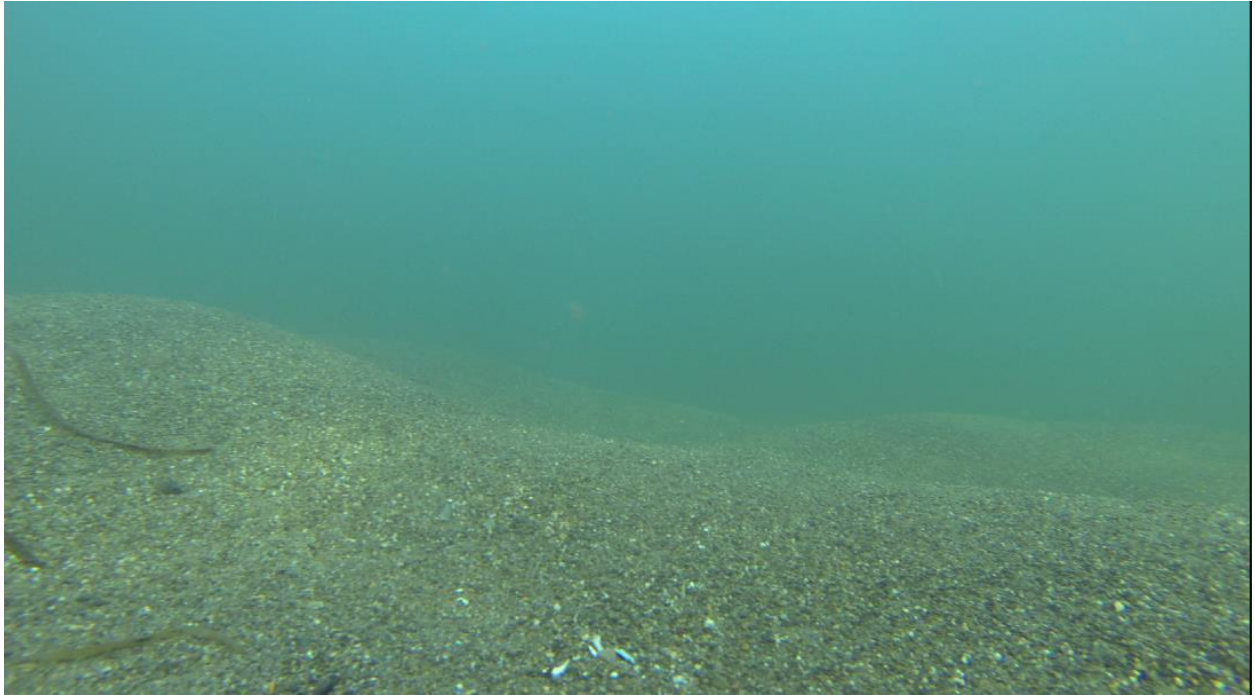
More of the undulating topography. Notice how close the sand “waves “ are – this can lead to more trapping of drift algae than really long period undulations.

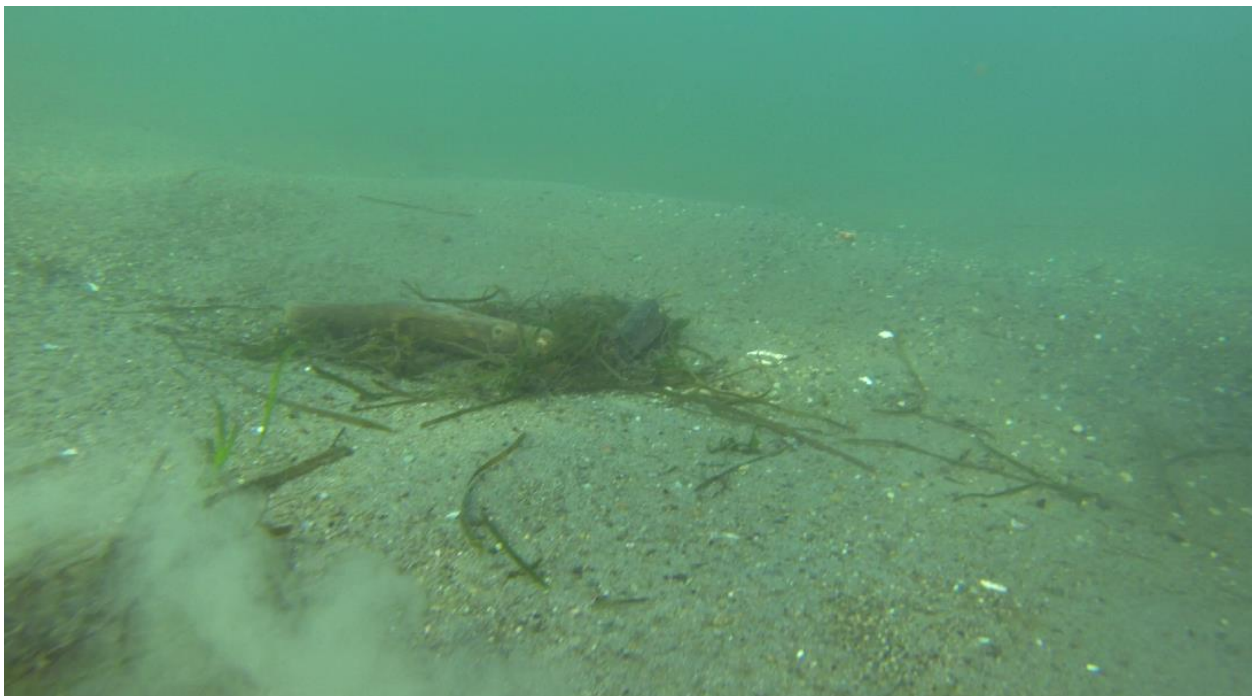
Starting leg 3 back to the east. Notice the finer sediment in the foreground and left, with more coarse grains to the right. Also shown is some drift eelgrass, algae, and woody debris (probably not trapped at the locations though).

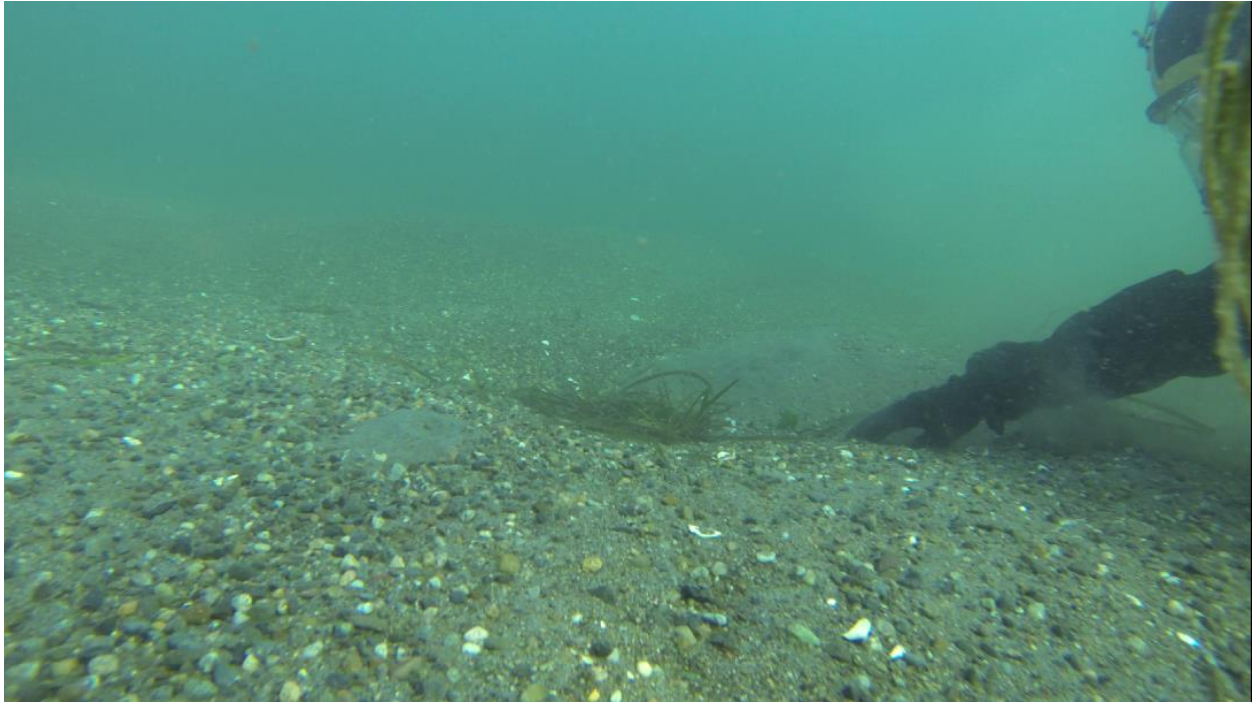
This irregularity is relatively small but probably would trap drift algae. The change in the sediment type is curious on the mound by the diver's hand.

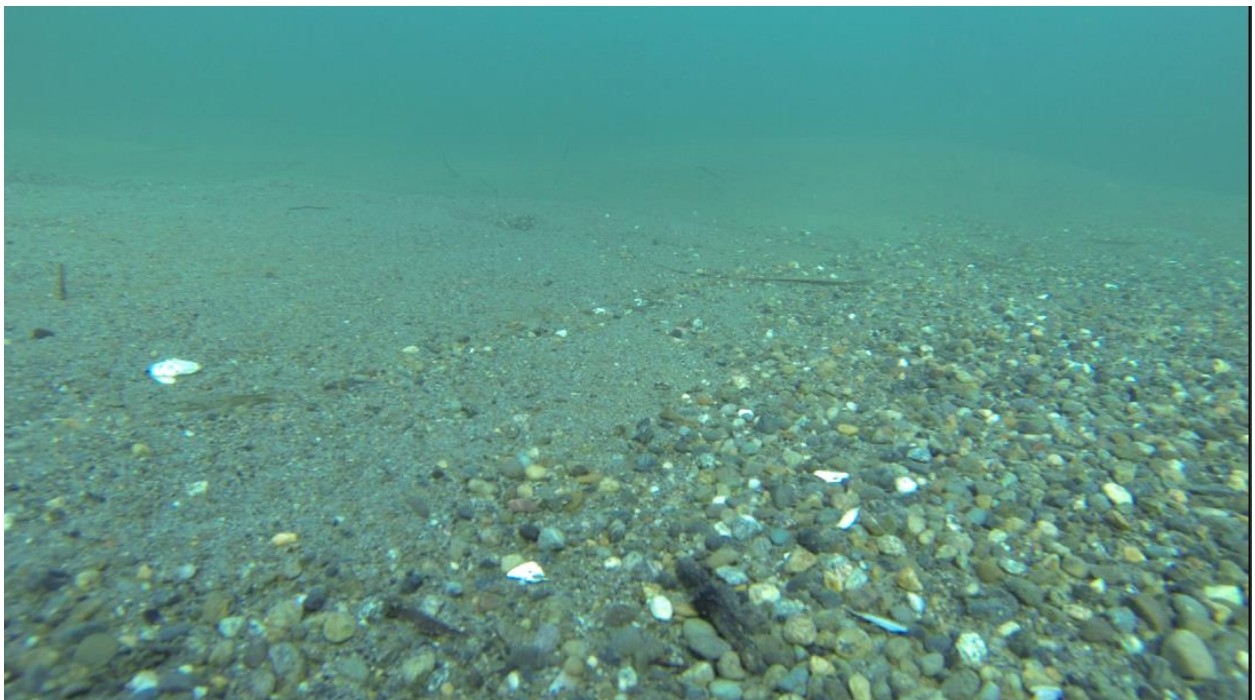
Transition from coarse to more fine sediment. The substrate on the left is better for eelgrass so long as it stays thick enough (this layer was thicker toward the center of the depression).

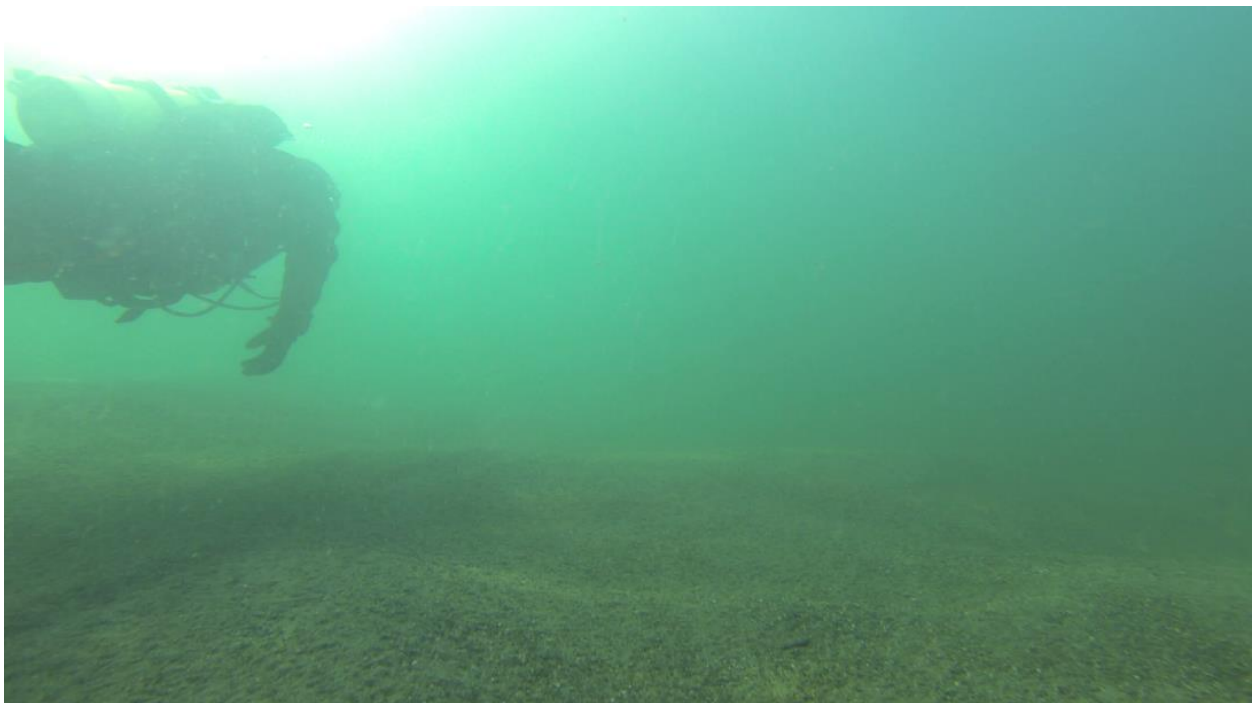
Moving toward the center of the depression on leg 4. The undulations are smaller but ubiquitous and the sediment is a better size.

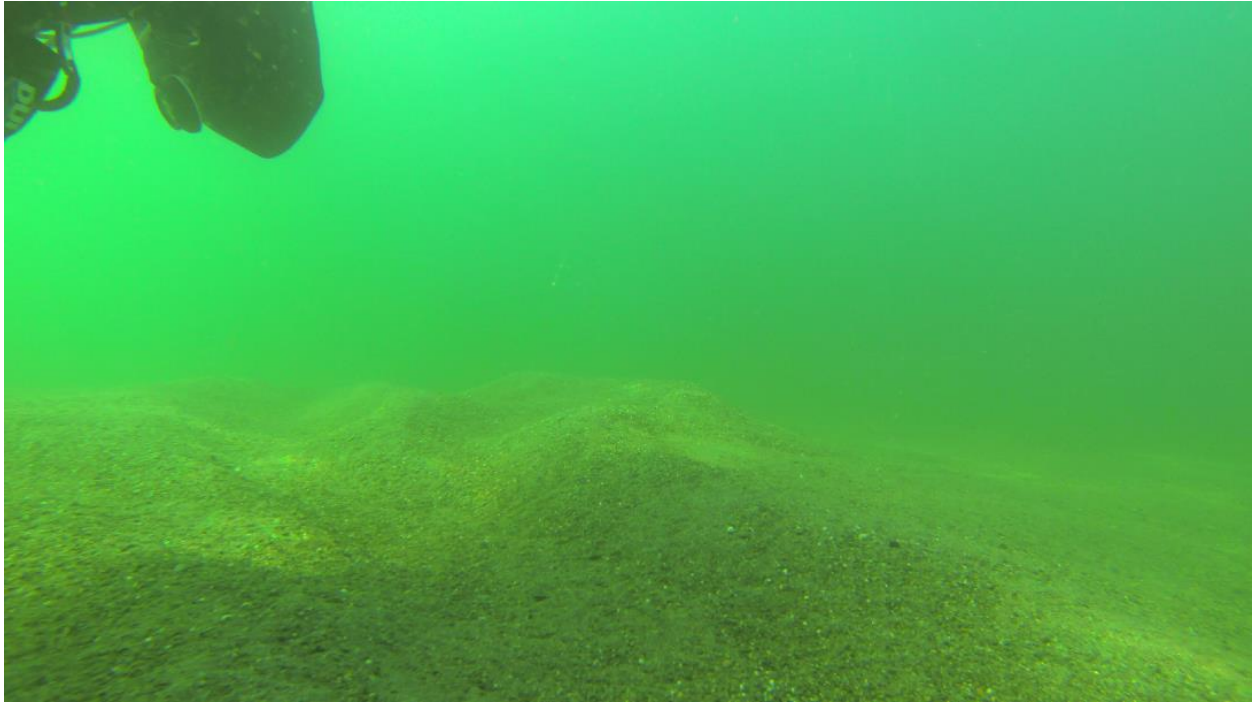
Many of the irregularities are small laterally and would be difficult to visualize from the surface and difficult to go back afterward and find to fix. These may certainly trap algae, but hopefully storms and longshore drift will help to smooth out over time.

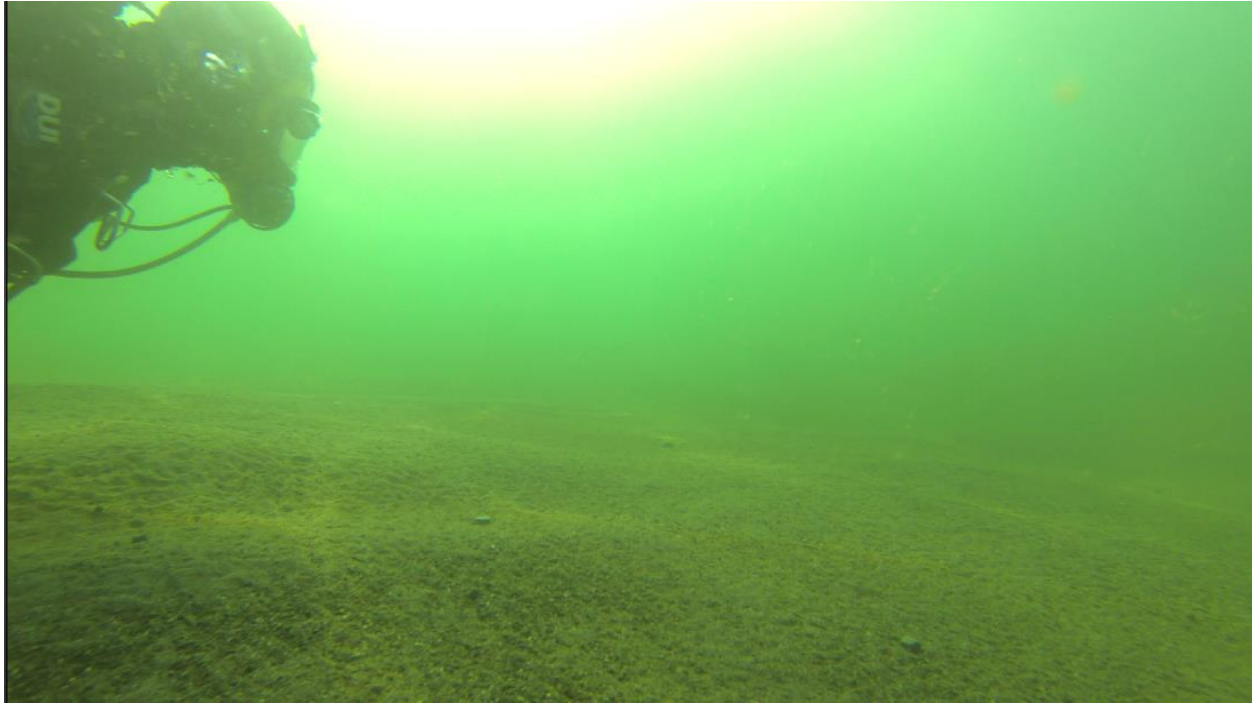
In many areas the undulations were small enough that they should not pose a problem for eelgrass, especially toward the center of the depression.

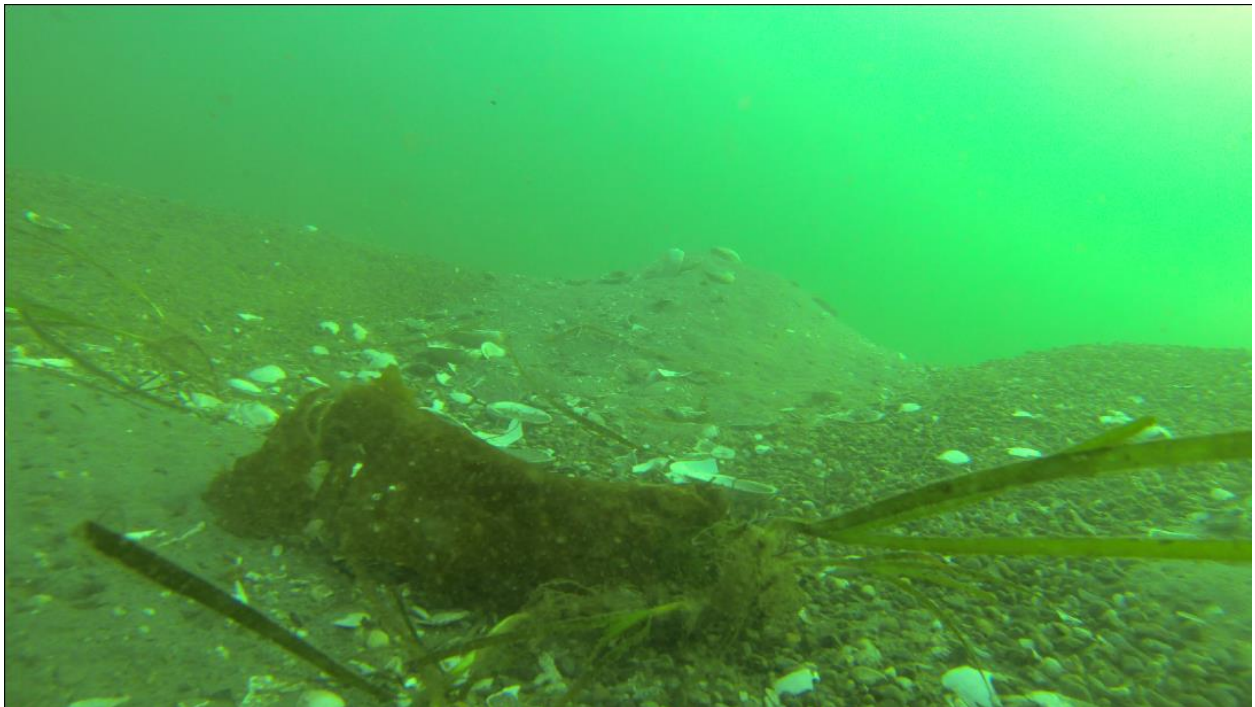
Odd location toward the end of leg 4 (toward the NW corner of the depression) that had very irregular topography and mounds with different sediments. Notice it is coarse on the right mound, very fine with high clay content in the middle, and closer to normal cap on the left.

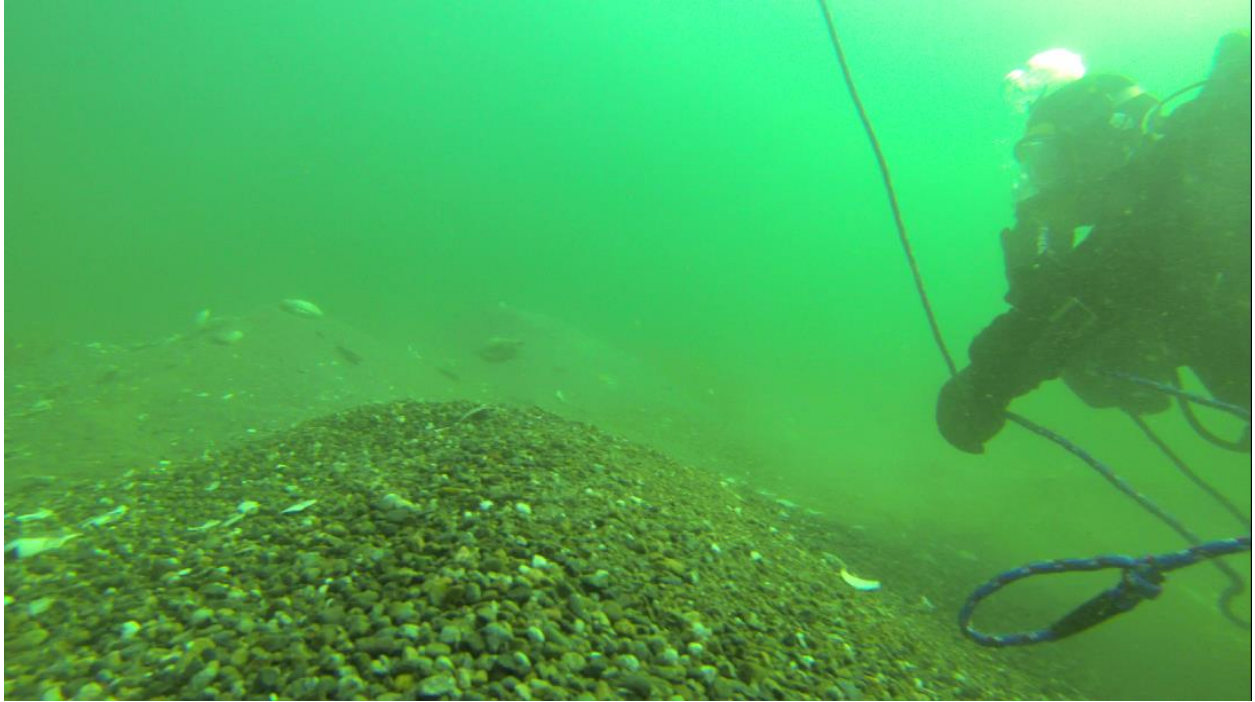
Another view of the irregular mounds. I am not sure where all the shell came from in this section.

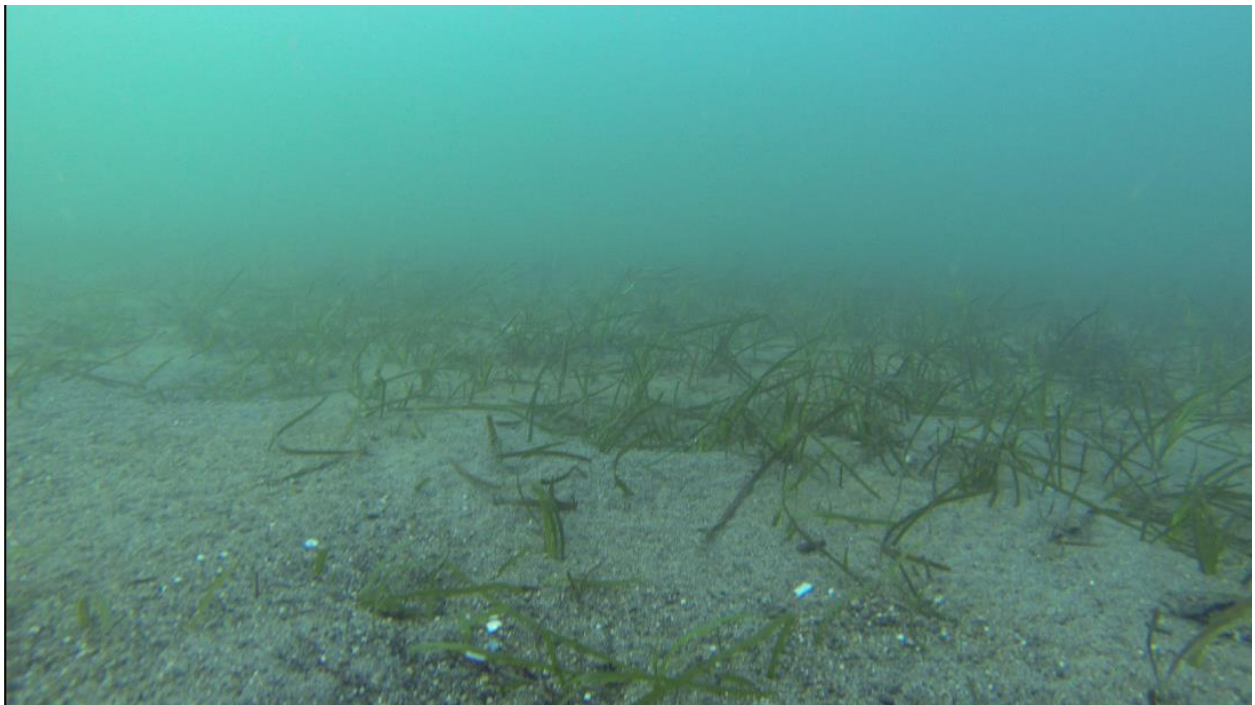
The northern edge and surrounding eelgrass. Any sediment that intruded here into the eelgrass appears to be finer and the layer is thinner. The grass seems to be handling it well.

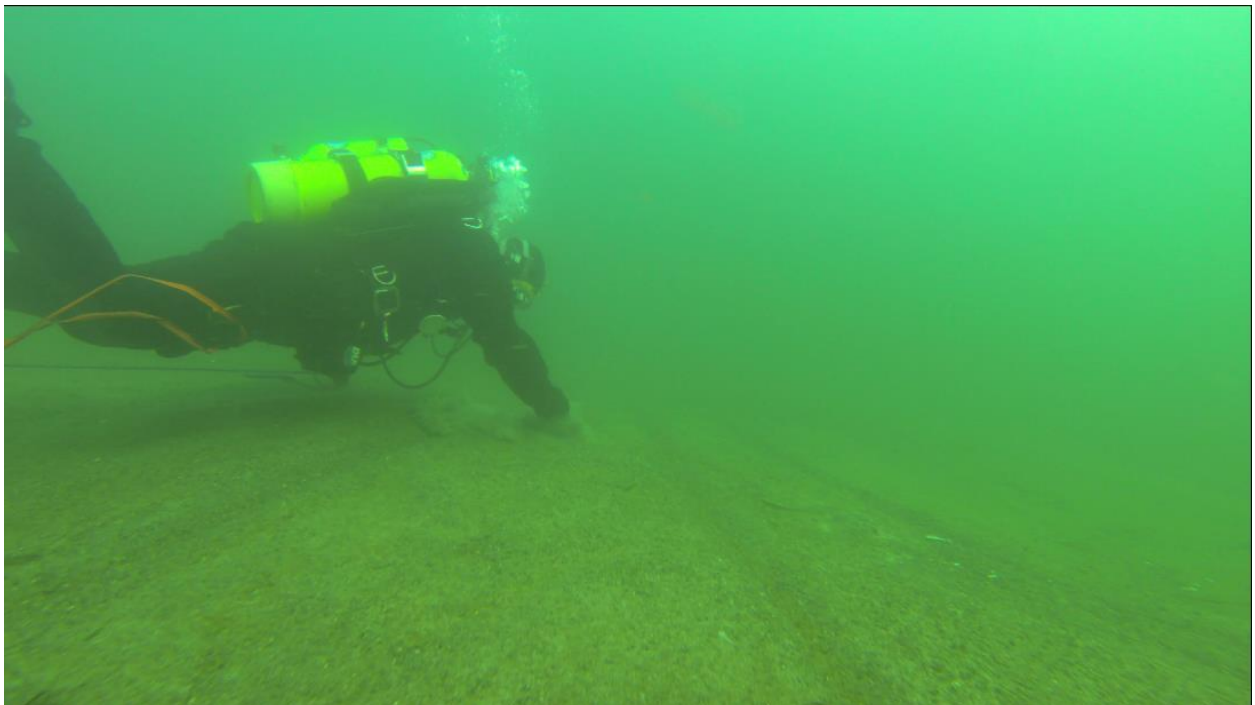
Nice flat stretch along the east side. You can still see some of the tool marks from the machinery.

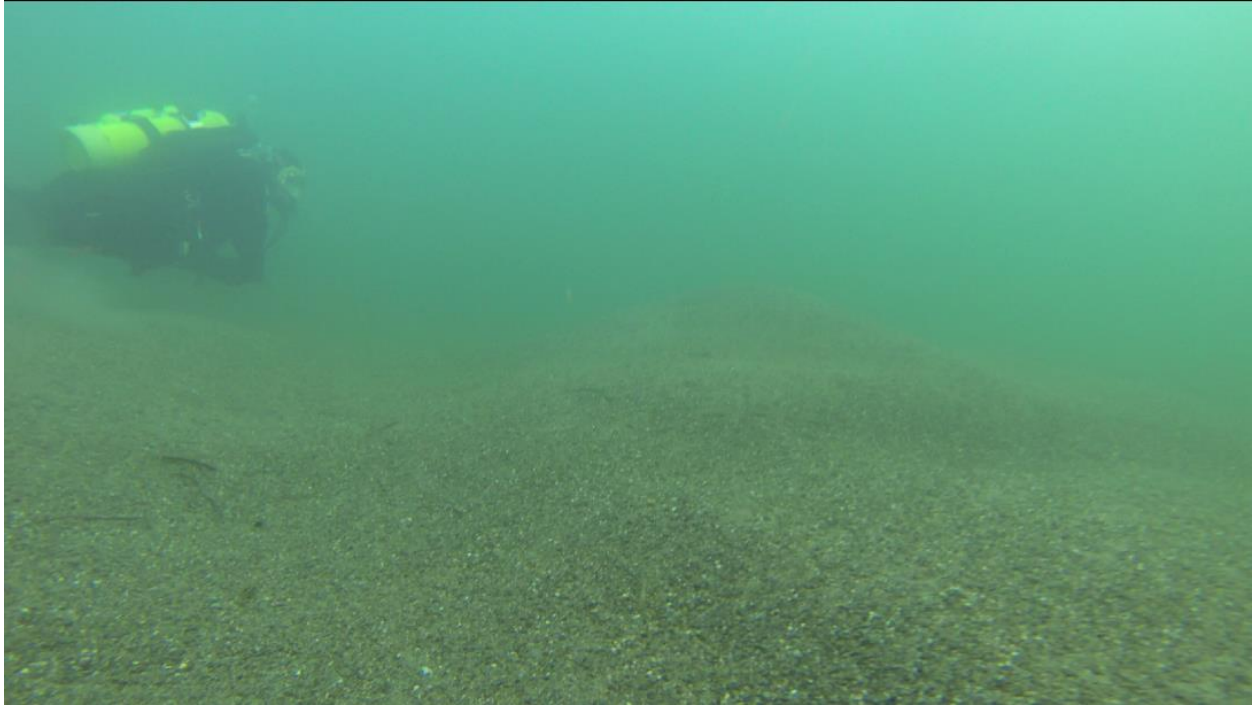
More irregular topography / mounding.

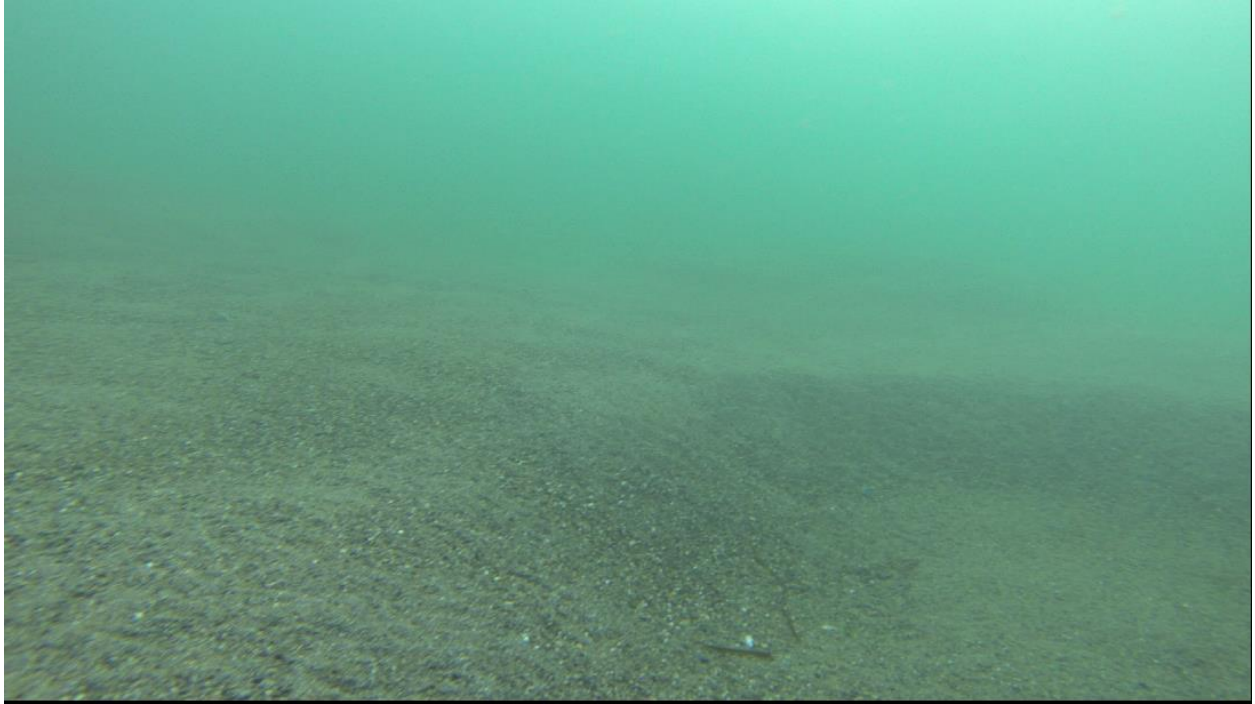
Even parts of the offshore edge could be relatively flat in stretches.

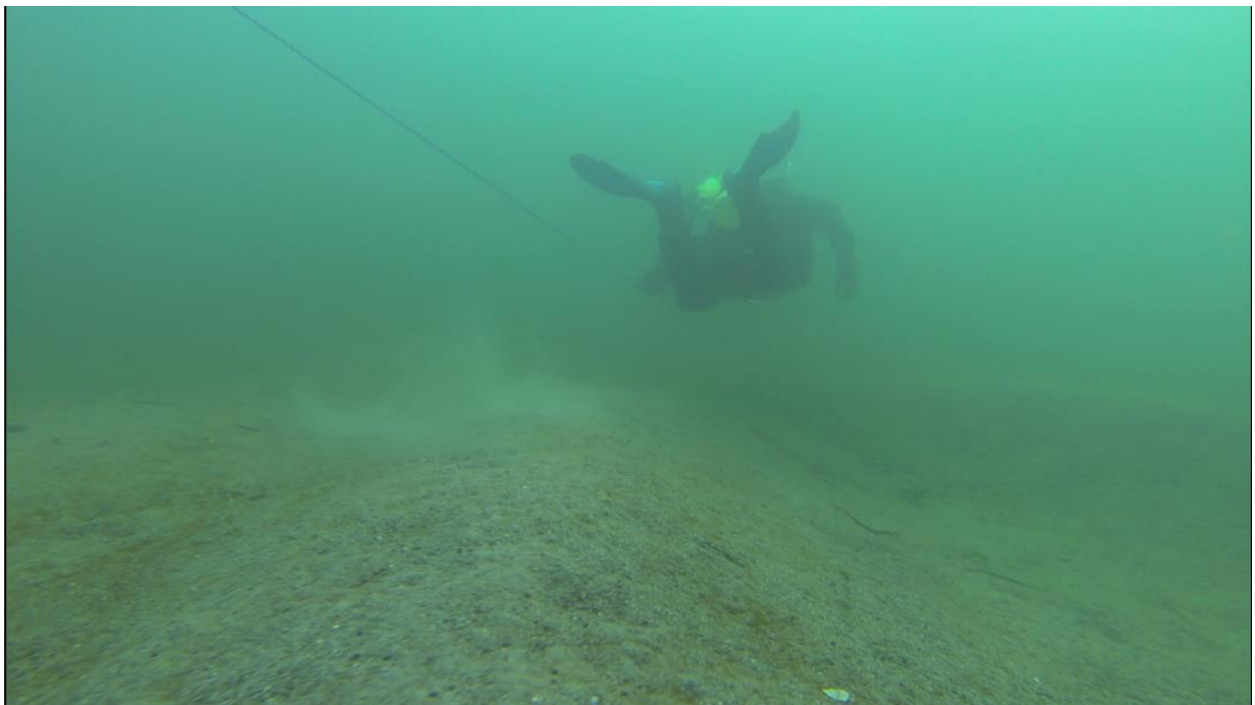
Some of these undulations on the offshore edge could be over a foot or two high.

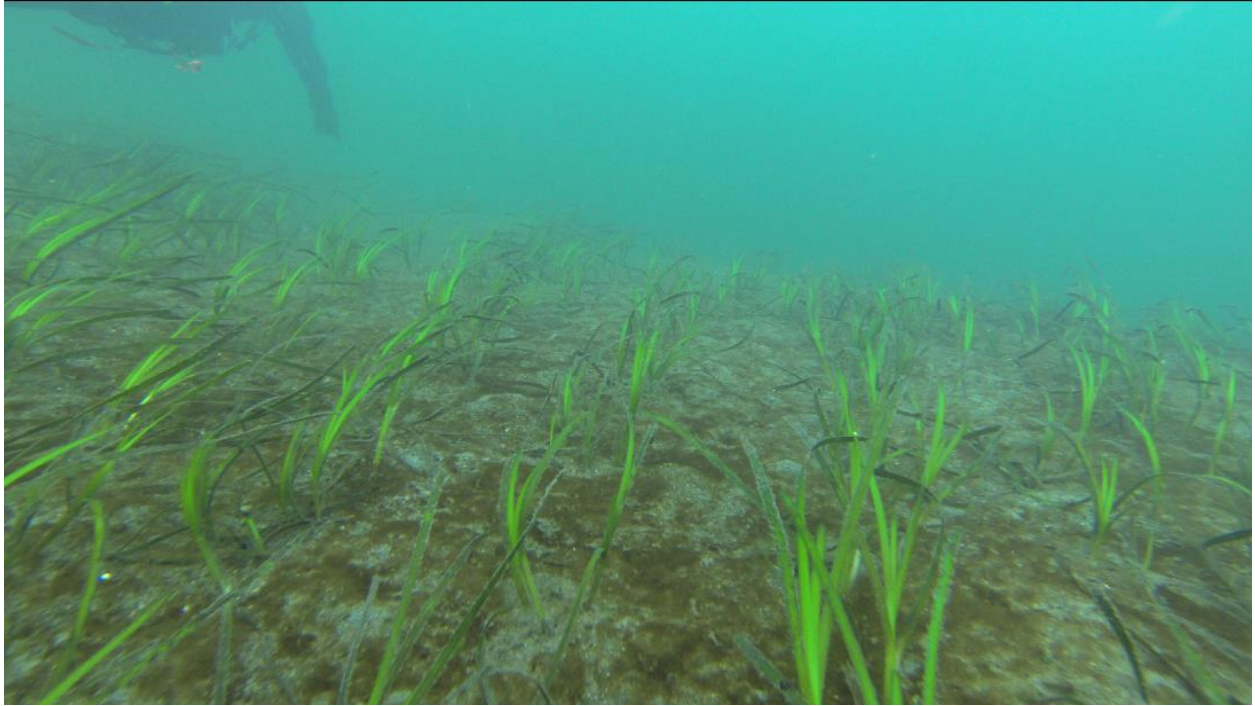
Eelgrass from the northern depression planted in the southern depression and looking very good from its winter condition.
